Prescott Peninsula Beaver Survey Results 2017

January 2018

Massachusetts Department of Conservation and Recreation
Division of Water Supply Protection
Office of Watershed Management
Natural Resources Section

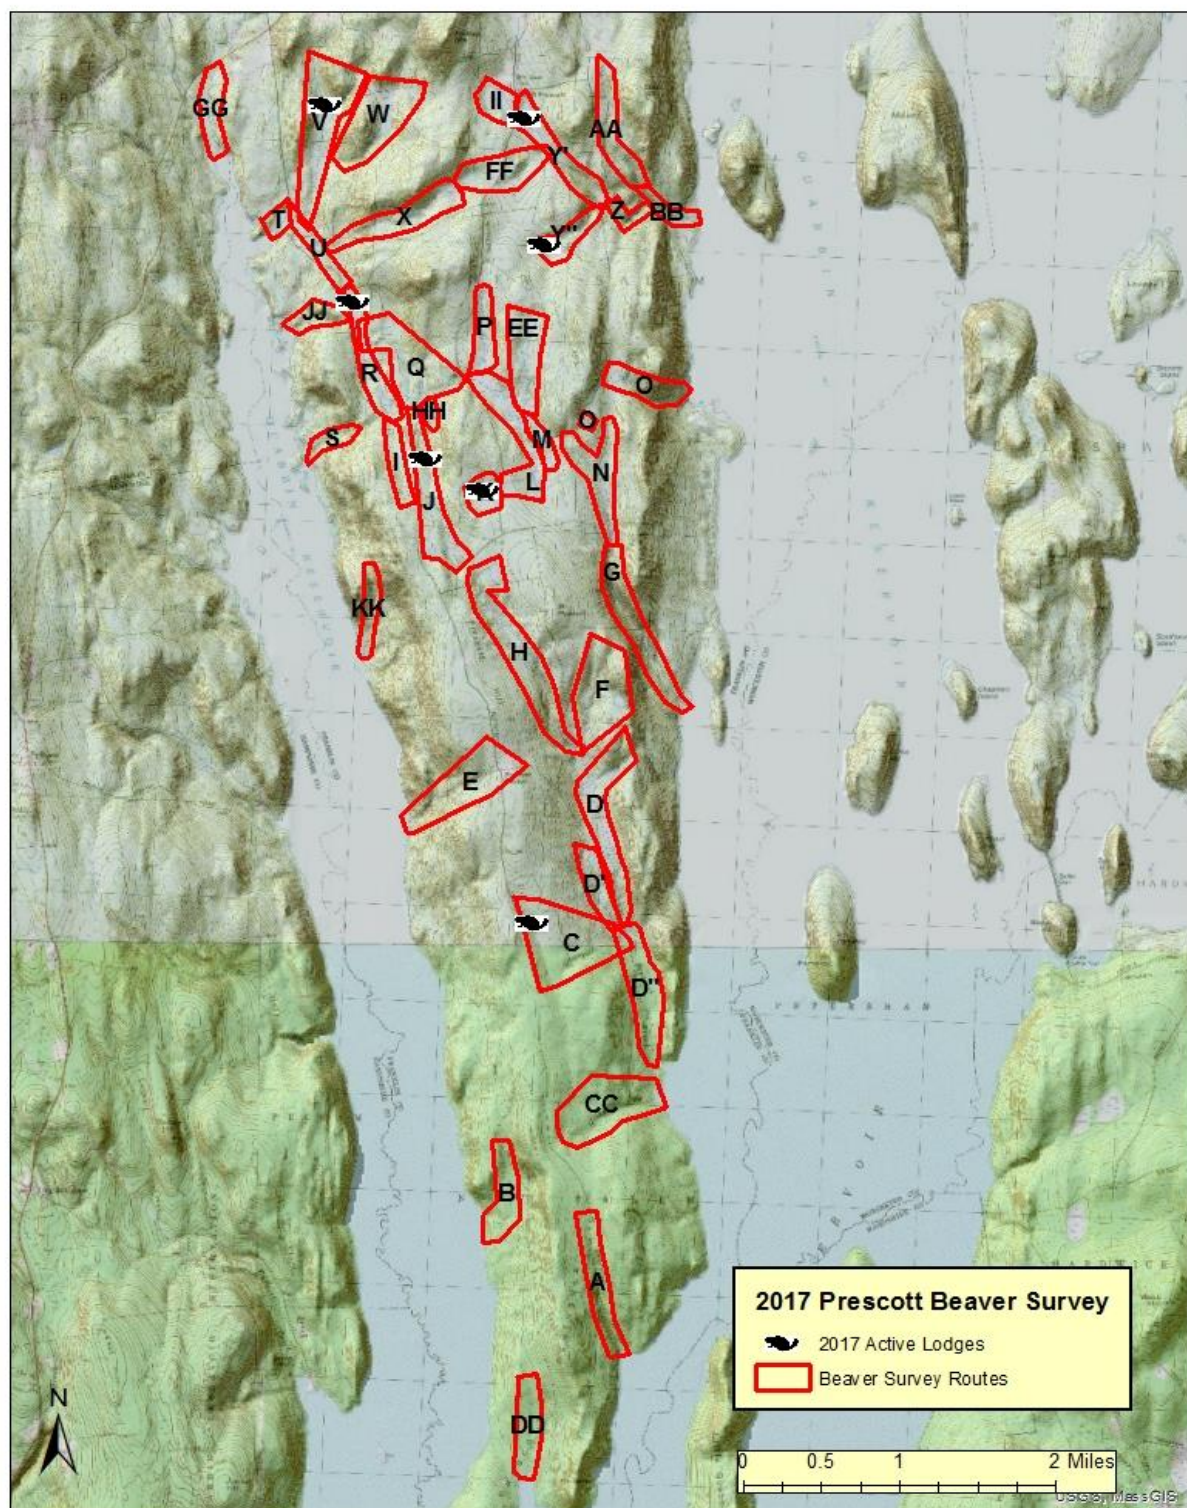
Figure 1. Active beaver sites on the Prescott Peninsula, Quabbin Reservation, 2017.

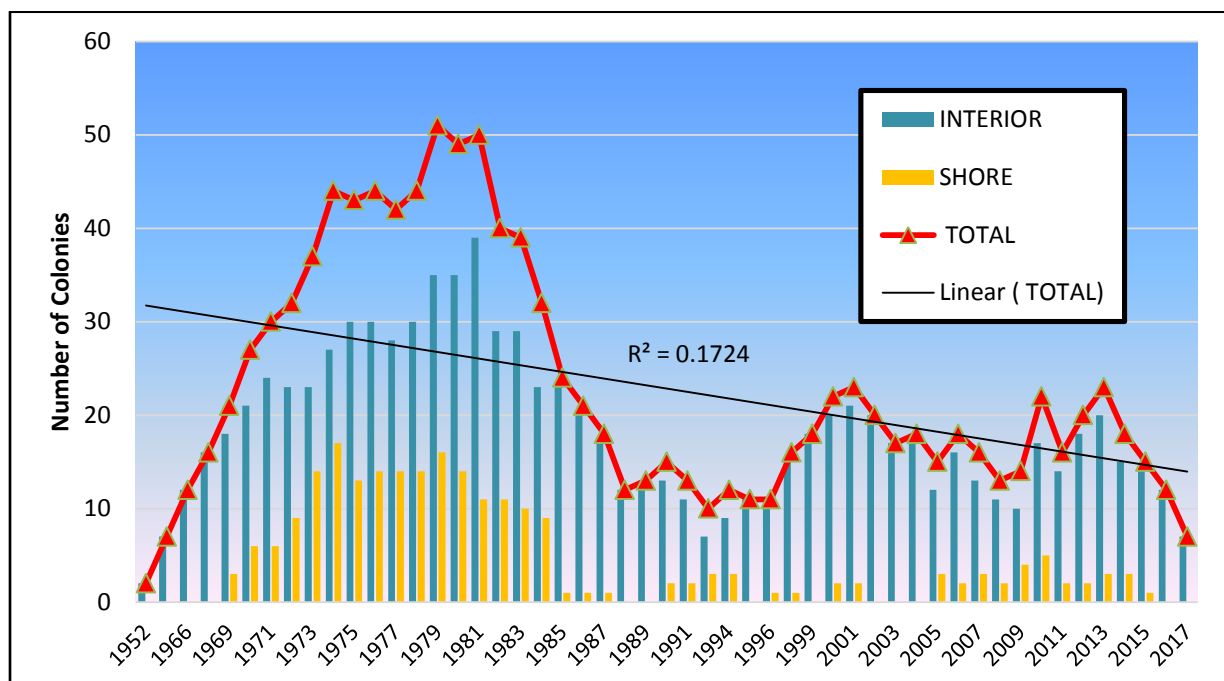
Figure 2. Number of active beaver colonies, Prescott Peninsula, Quabbin Reservation, 1952-2017.

There were 7 active beaver colonies (7 interior and 0 along the shoreline) documented on the Prescott Peninsula during the 2017 survey. This relatively low count of 7 was also recorded in 1960 and 1993. A downward trend has continued from a total of 23 active colonies in 2013 to 7 in 2017. There were 6 interior survey routes that were active in 2016 and still active this year, along with 1 re-colonized site. Detailed locations are provided in Table 1. Locations of active sites are shown in Figure 1. Long-term population trends for beaver on the Prescott Peninsula over the last 50+ years are summarized in Figure 2.

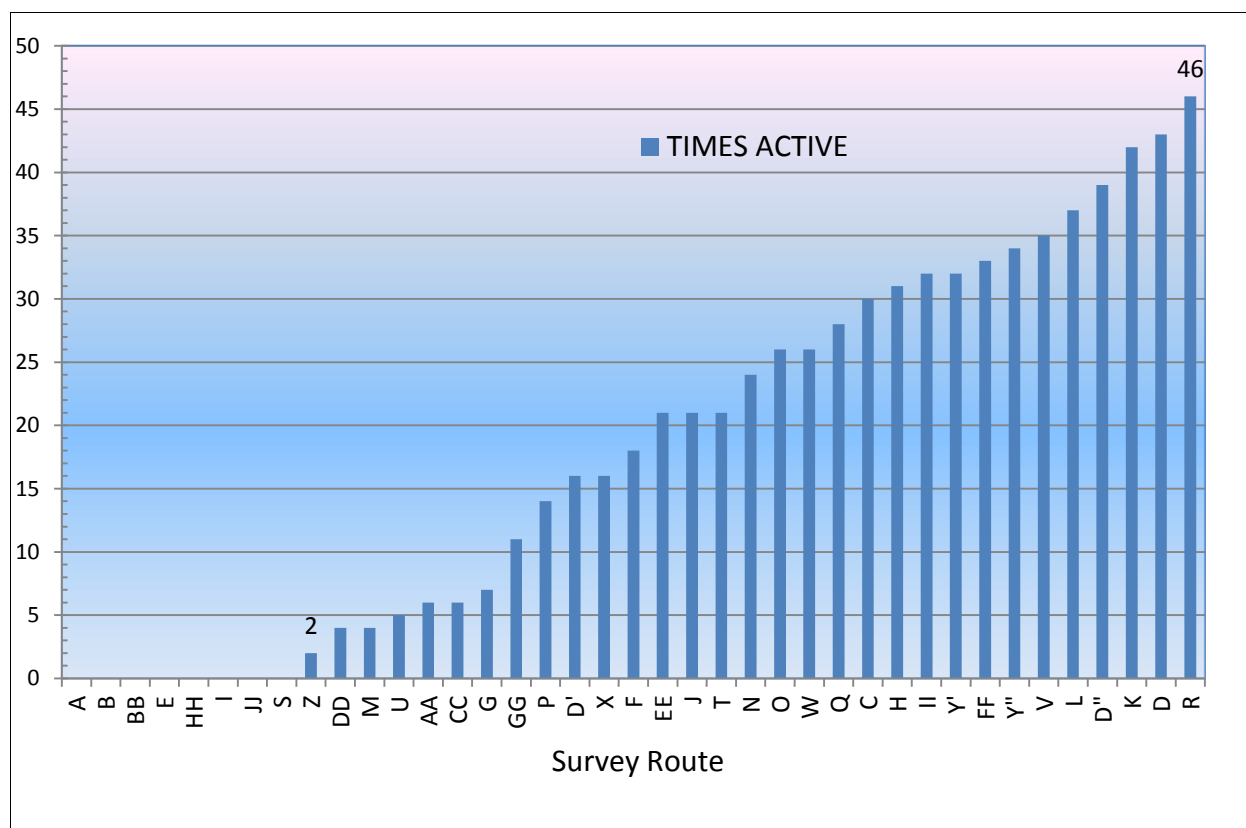
Figure 3. Number of times defined routes have had active beaver colonies on the Prescott Peninsula, Quabbin Reservation, 1952-2017.

There are 39 defined interior routes (ponds, partial or complete drainages, etc.) that have been surveyed for beaver colonies for 51 years from 1952-2017. The numbers of beaver colonies in these routes have ranged from 2 when the surveys began in 1952 to a high of 39 in 1981. Beaver use of these survey routes ranged from 0 (never had an active beaver colony) to 46 (i.e., number of times, or years, a route had an active beaver colony or colonies). Eight of the survey routes have never been active and the remaining 31 of the 39 routes have had active beaver colonies at least 2 times. The number of times each survey route has been active is summarized in Figure 3.
