Working with Beaver to Restore Salmon Habitat in the Bridge Creek Intensively Monitored Watershed

Design Rationale and Hypotheses

NOAA Technical Memorandum NMFS-NWFSC Series

Pollock, M.M., J.M. Wheaton, N. Bouwes, C. Volk, N. Weber, and C.E. Jordan. 2012. Working with beaver to restore salmon habitat in the Bridge Creek intensively monitored watershed: Design rationale and hypotheses. U.S. Dept. Commer., NOAA Tech. Memo. NMFS-NWFSC-120, 47 p.

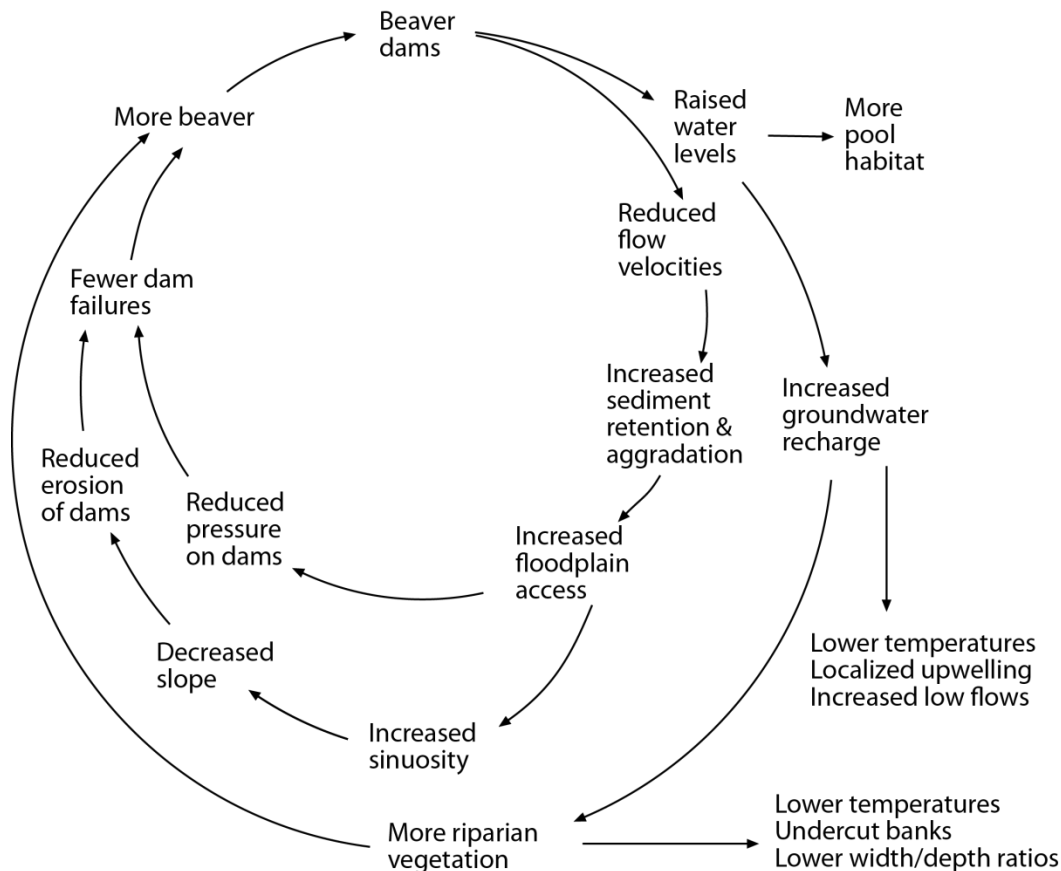
Figure 4. Conceptual diagram of the hypothesized positive physical feedback loops for beaver and steelhead from the presence of beaver dams. The key barrier to this feedback loop in Bridge Creek is that individual dams do not persist long enough to realize or maintain the hypothesized benefits.

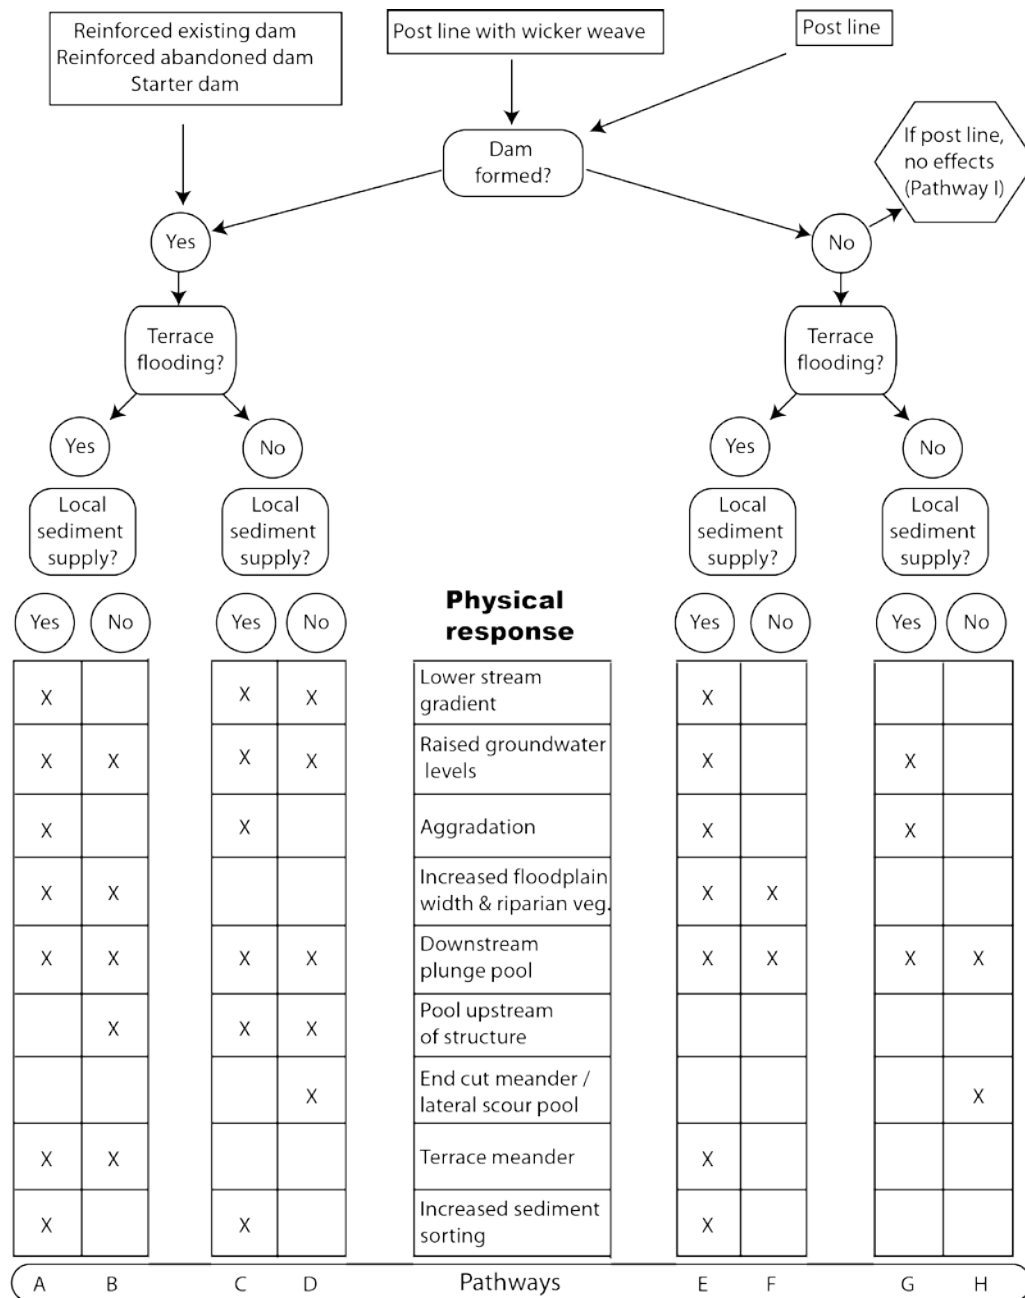
Figure 5. A BDS structure can follow multiple pathways (A through I), depending on the type of structure and the natural processes acting on it. Thus the predicted hydrogeomorphic changes created by a structure largely depend on the timing, sequence, and magnitude of natural processes such as beaver dam construction, debris transport, bank failures, and floods.

of sediment sources (e.g., coarse gravels in Bridge Creek often sourced locally from bank failure of coarse-grained alluvial deposits). Likewise, for a PLWW, the hydrogeomorphic response of the stream to the structure will largely depend on whether or not it is colonized by beaver. The structures are designed to follow multiple pathways, with multiple possible outcomes, depending on the stochastic events acting upon them. Thus the structure-specific objectives can best be thought of as a series of if-then pathways in a flow chart (Figure 5). Defining objectives for the

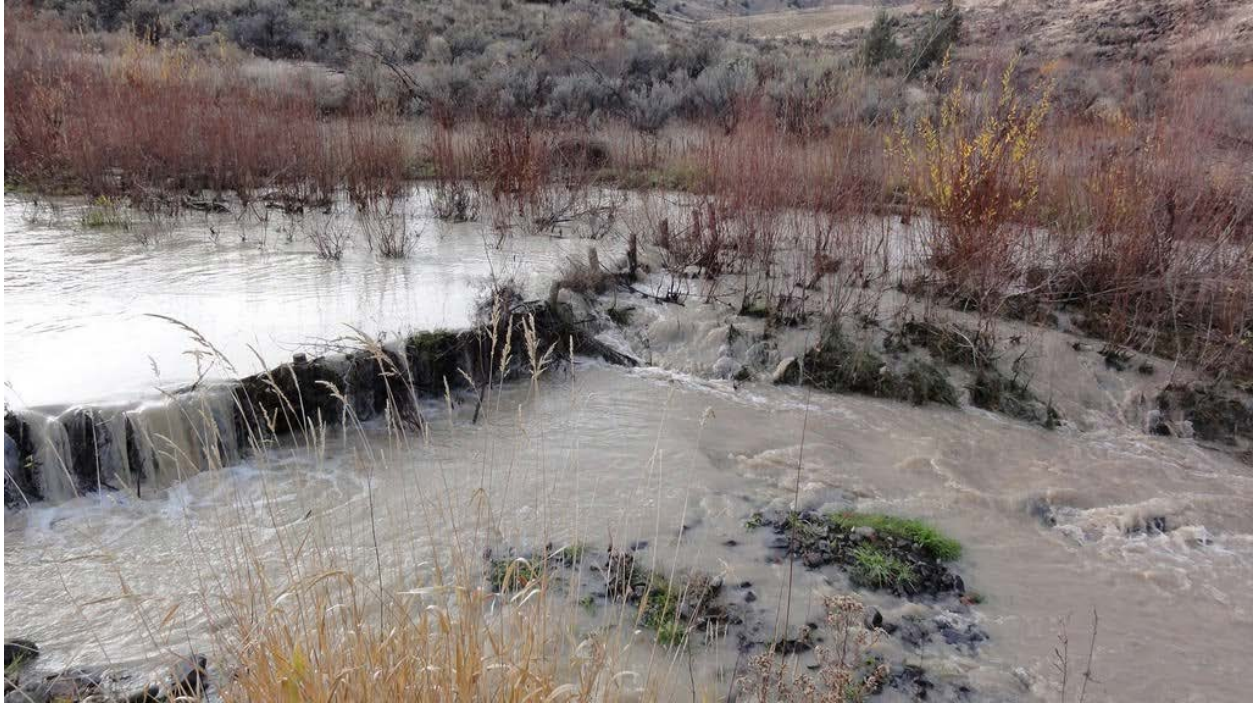
Figure 10. A typical SD (SF-17 at Sunflower) with willow branches woven between vertical posts and the back side sealed with rock and clay. Note that the dam height is sufficient to divert flow onto the river left terrace, mimicking a stable beaver dam.
